Lilienthal's Fatal Glider Crash in 1896: Evidence Regarding the Cause of Death

VIKTOR HARSCH, BENNY BARDRUM, AND PETRA ILLIG

HARSCH V, BARDRUM B, ILLIG P. *Lilienthal's fatal glider crash in 1896: evidence regarding the cause of death.* *Aviat Space Environ Med* 2008; 79:993–4.

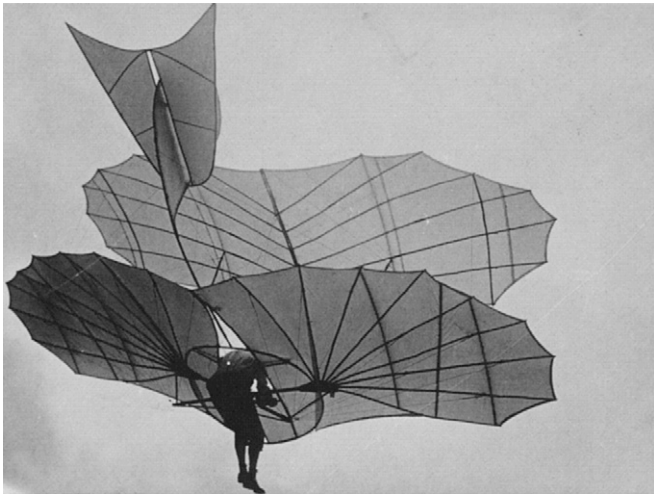
A visiting American physicist, Robert W. Wood, watched Lilienthal flying a week before the crash. His photograph (Fig. 1) shows that Lilienthal flew his glider while wearing street clothing without a helmet or anything else we would recognize today as protective devices. During flight, his forearms were inserted into sleeves on the frame with his elbows flexed, supporting his upper body within the wing structure while his lower body hung vertically below. The glider was controlled by the movement of Lilienthal's lower body shifting the glider's center of gravity and thus altering pitch and bank. He landed on his feet, running, and in an emergency could quickly separate from the glider by releasing his arms and dropping away from the frame. We report here on our investigation regarding the fatal crash that occurred at Gollenberg Hill near Stoelln at about noon on August 9, 1896.

Fig. 1. Otto Lilienthal with his double decker at the Fliegeberg, Berlin, October 19, 1895. Photograph by Dr. Richard Neuhaus. Courtesy of the Otto Lilienthal Museum, Anklam, Mecklenburg-Vorpommern, Germany. Picture No. OLM F0941LF.
